POST-MORTEM EXAMINATION OF  
MK 28 COMPONENTS FROM  
THE PALOMARES, SPAIN ACCIDENT (CRD)

This report is a compilation of post-mortem results on components returned to Sandia Corporation from the B52/KC135 aircraft refueling accident near Palomares, Spain on January 17, 1966. Information on this accident and subsequent weapon recovery operations is contained in Reference No. 1.

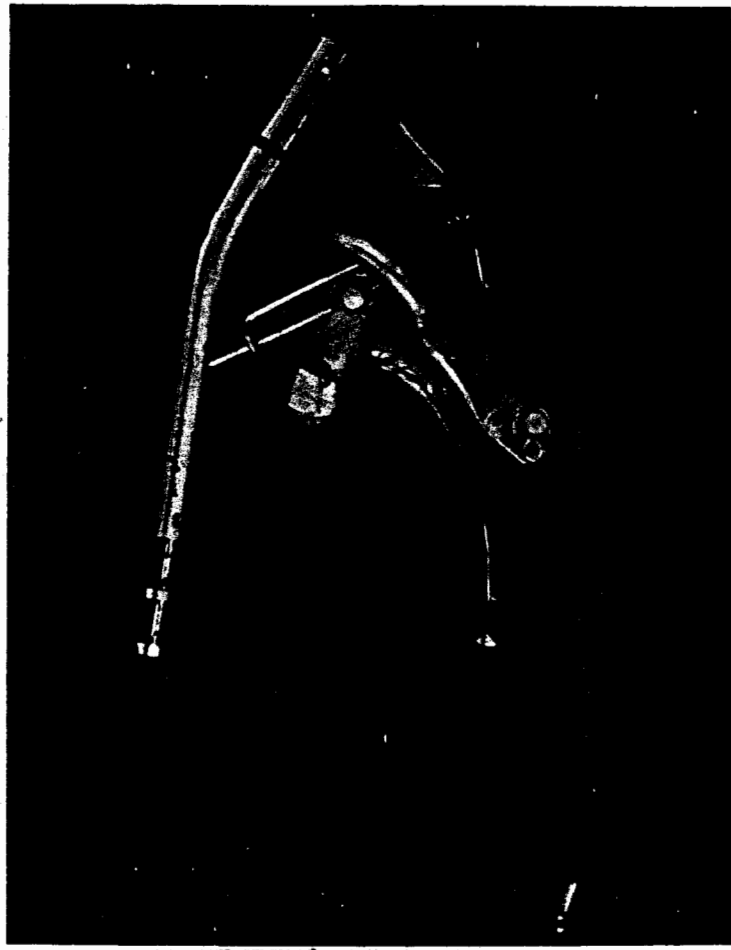
FIGURE 1

MC1120 Single Pulse Generator Serial Number BBN6909A3 -- The MC1120 was received with one pullout rod withdrawn and bent. (See Appendix Figure 1.) No other deficiencies were evident. A spare pullout rod was inserted in lieu of the bent one.

Pullout Rod from MC1120  
S/N BBN 6909A3
